The history of the building

This chapter traces the history of the Old Museum Building. Its purpose is to sketch the major events in the story of the place as an introduction to the discussion of significance later in this report.

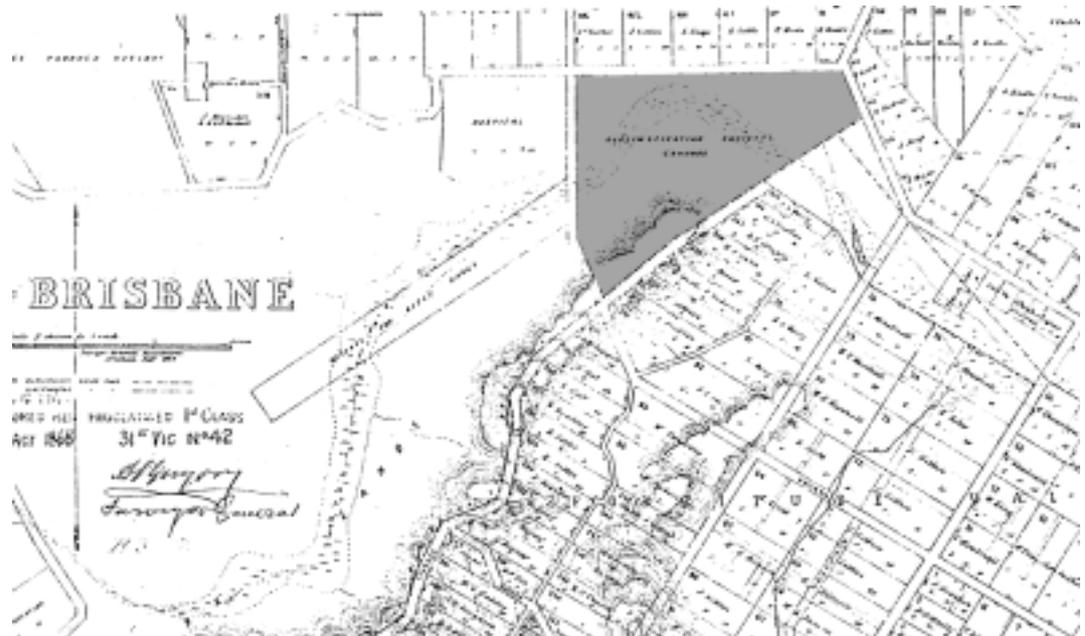
5
Survey plan, 1868, showing the land granted to the Acclimatisation Society (shaded) partly surrounded by suburban allotments, and bordered by the hospital and a rifle range.

This land was the area now bounded by Bowen Bridge Road, O'Connell Terrace, Brookes Street and Gregory Terrace and became known as Bowen Park.⁷ (see illustration 5, which shows the extent of this land grant). The society used the site to grow and propagate the plants and seeds sent from other parts of the colony and around the world. They built an office and boardroom, bush-house and glass-house, and had an orchard and gardens for decorative plants. Various introduced animals were kept and grazed on the site. It seems the plantings were extensive and quickly developed. By 1871 the society's garden was seen as a place of public instruction and recreation.⁸ In 1887 the creek in the lower area, where the railway now runs, was dammed to form a series of decorative ponds.

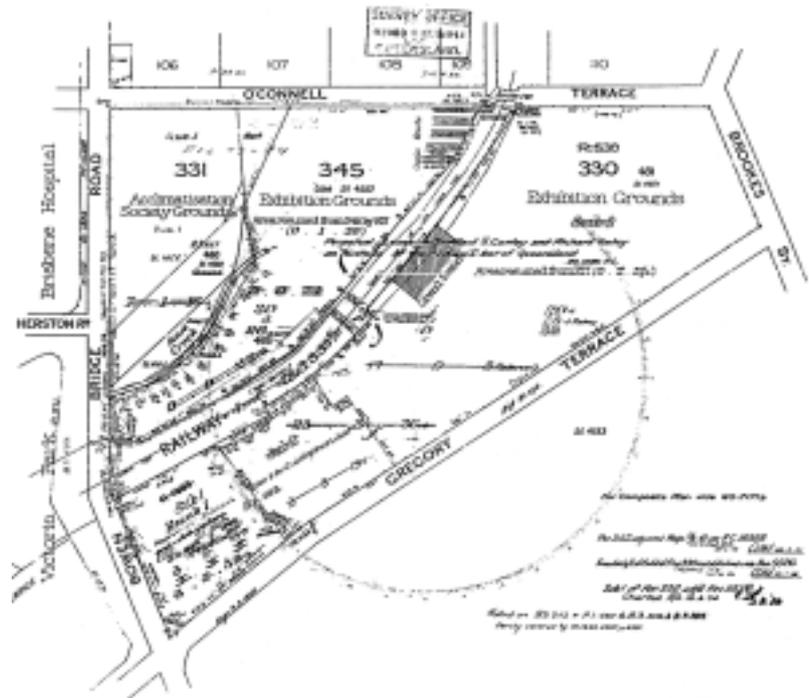
8
1913 survey plan, showing the Acclimatisation Society grounds reduced to a fraction of its original area after land was taken for the exhibition grounds and the railway.

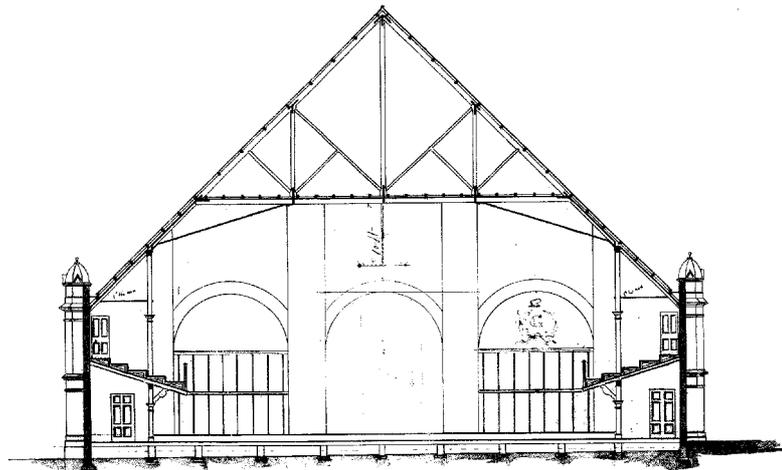
10
Cross section through the concert hall wing, one of the contract drawings.

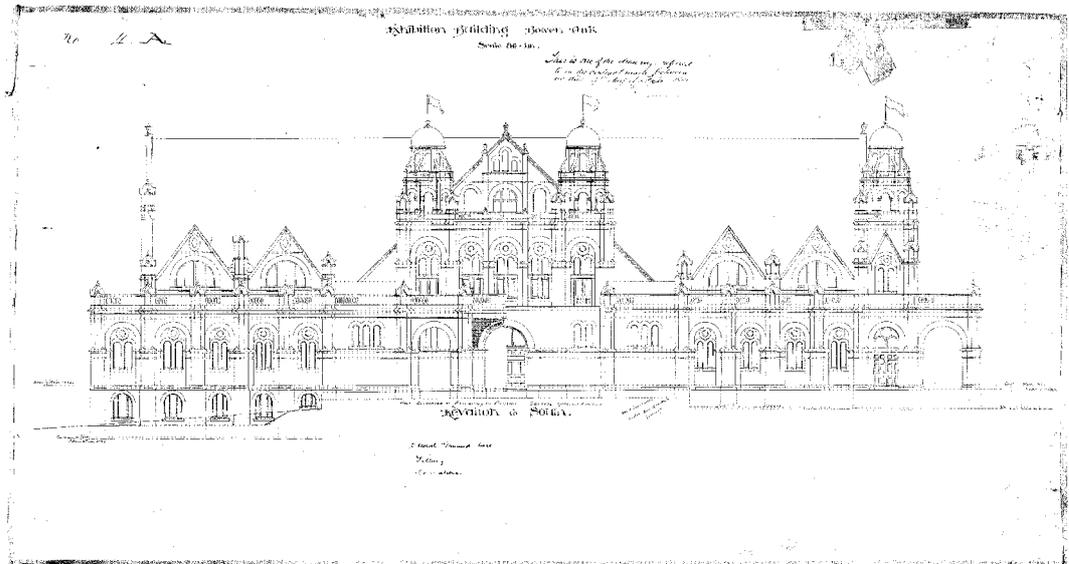
11
Addison's drawing of the south elevation, one of the contract drawings. In the centre is the entrance to the concert hall; on the right is the entrance to the exhibition hall; on the left, at the lower level, is the entrance to the dining room.

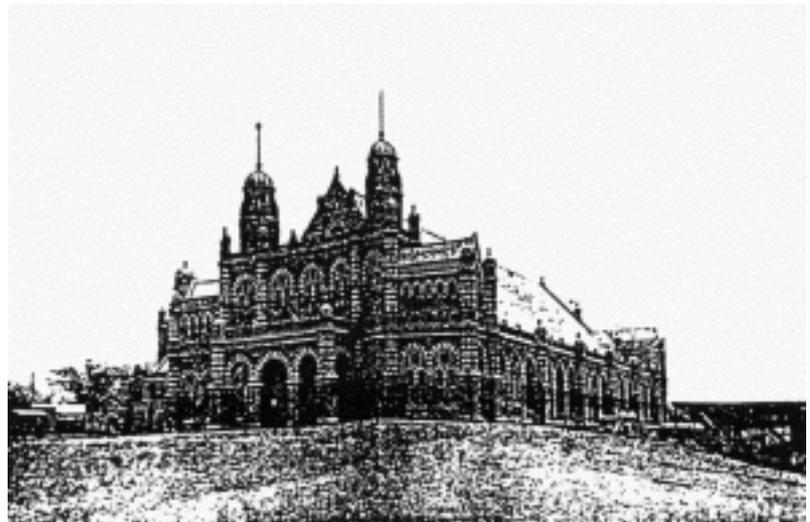
13
The earliest known photograph of the Exhibition Building, published in the Building and Engineering Journal in December 1891.

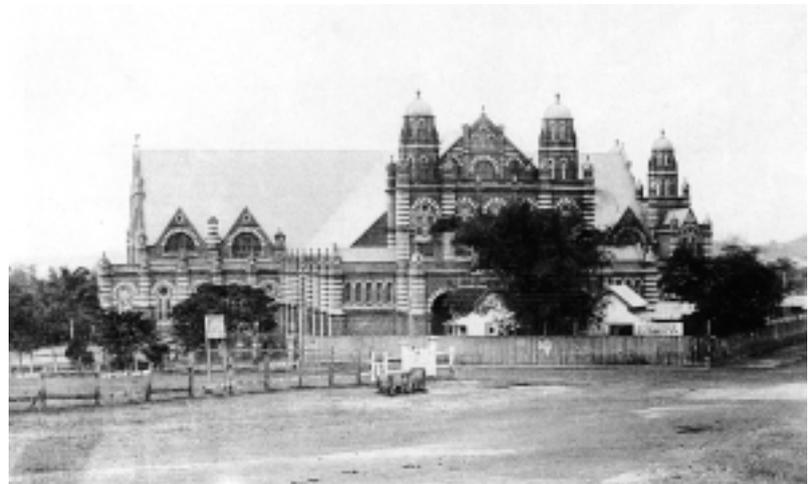
14
The Exhibition Building around 1895 – the clumps of bamboo, the timber cottages and the paling fence at the corner were all removed soon after, to allow a proper entrance to be formed for the concert hall. [JOL 61132].

Gregory Terrace. Photographs taken around 1895 and 1897 show the caretaker's residence and ladies' cottage in front of the building in the corner of Bowen Bridge Road and Gregory Terrace. A paling fence extends along these street frontages and two large stands of bamboo screen much of this southern elevation. These cottages and bamboo are noted on an 1897 plan. The grounds to the north were devoted to exhibitions. A connection, possibly a bush house, is shown from the exhibition hall to the main display area.

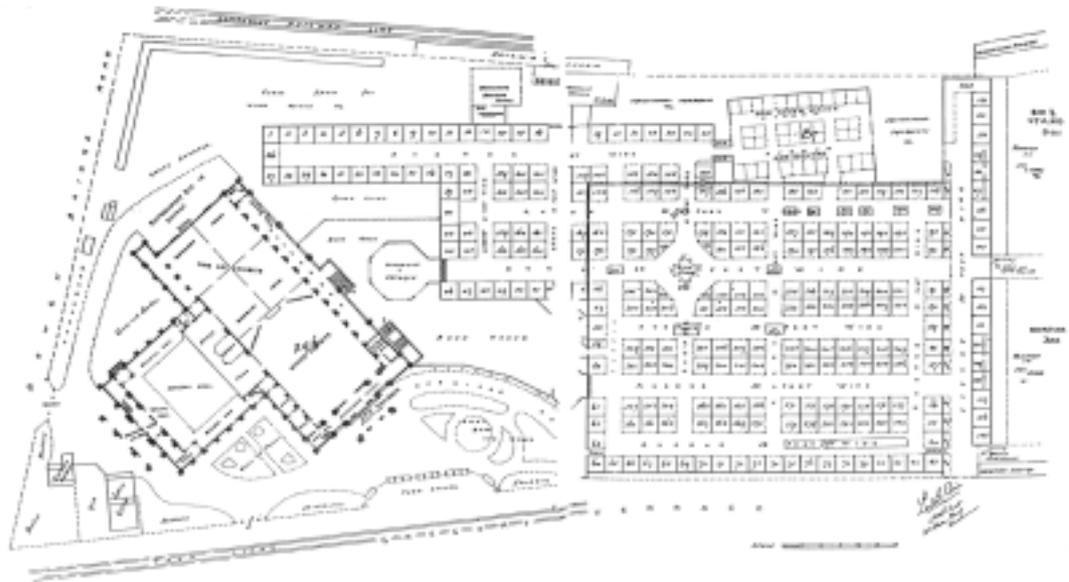
15
Leslie G Corrie's plan of the building and grounds, copied from the program of the 1897 Queensland International Exhibition.

The earliest known detailed plan of the grounds is one prepared in 1897 by Leslie G Corrie, architect, for the Queensland International Exhibition (illustration 15). This plan shows a formal layout of carriage drive, pathways, shrubbery, flower beds and a fountain. Bush houses abutting and extending from the northern side of the Exhibition Building framed and terminated the avenue approach from the exhibition grounds. The main entrance remained from Bowen Bridge Road with the carriage drive running in front of the concert hall porte-cochère, around into the porte-cochère of the exhibition hall then curving out to the gate on Gregory Terrace. Shrubberies are indicated along Bowen Bridge Road and Gregory Terrace between the fence and drives. A formal arrangement of grass-edged flower beds, with a fountain as the centrepiece of one, are laid out within the curve of the carriage drive.

The plan of the Queensland International Exhibition 1897 (illustration 15) indicates how the exhibition hall was used - half the space was devoted to mining exhibits (illustration 16) and the other half to a fine arts display. The adjacent verandah was used to display specimens of Queensland coke and coal. The fine arts section of the hall was further subdivided with timber partitions into four areas, displaying Australian, Foreign, British and Queensland items.

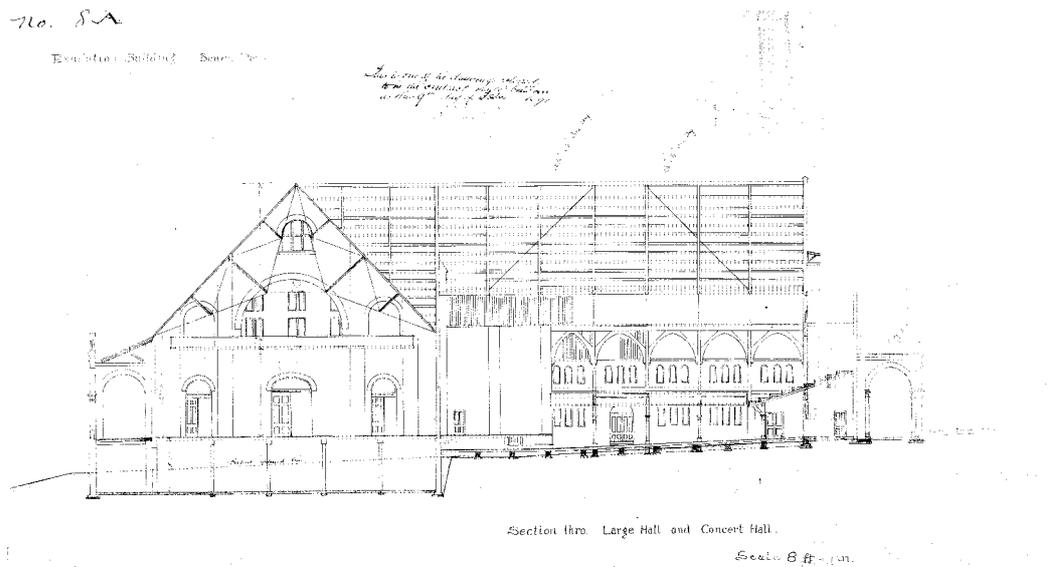
17
One of G H M Addison's 1891 contract drawings, a section cutting across the exhibition hall and dining room (on the left) and along the centre line of the concert hall (on the right). In the concert hall, note the slightly raked floor and the gallery at the back and sides of the auditorium.

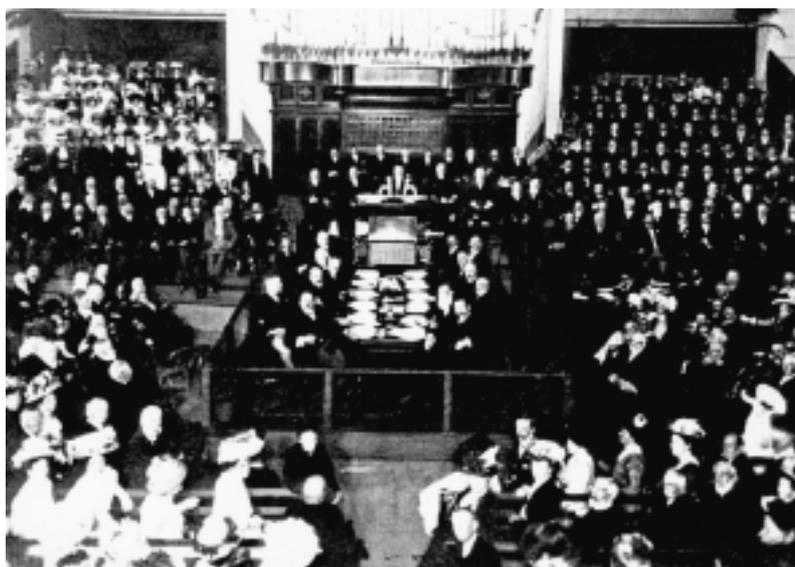
18

A photograph of the concert hall interior thought to date from the 1920s. People are sitting on the choir platforms to either side of the organ, as well as in the auditorium. [Queensland Museum photo].

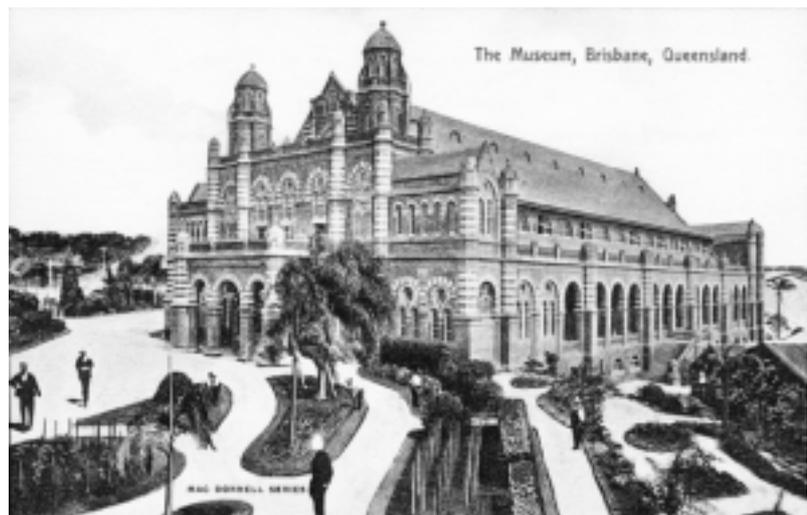
19
A postcard of the museum. See the clerestory windows and dormer roof vents added during the conversion. [Author's collection].

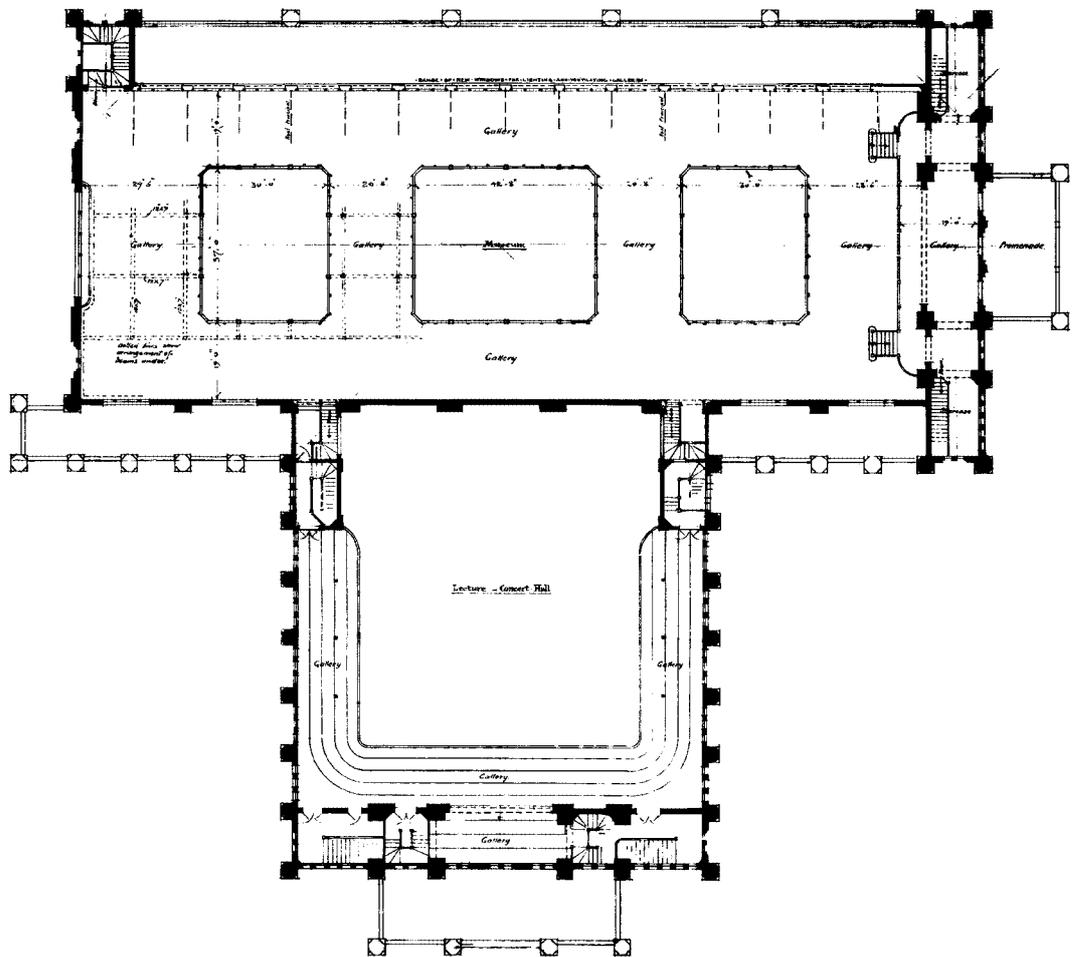
20
A contract drawing for the museum conversion of 1897. This plan shows the layout of the mezzanine floor introduced in the exhibition hall.

Pye was probably involved in the design of the conversion. Whoever its author was, the architectural skill of the conversion must be acknowledged. Several of the contract drawings for the museum conversion are reproduced here (see illustrations 20, 21).

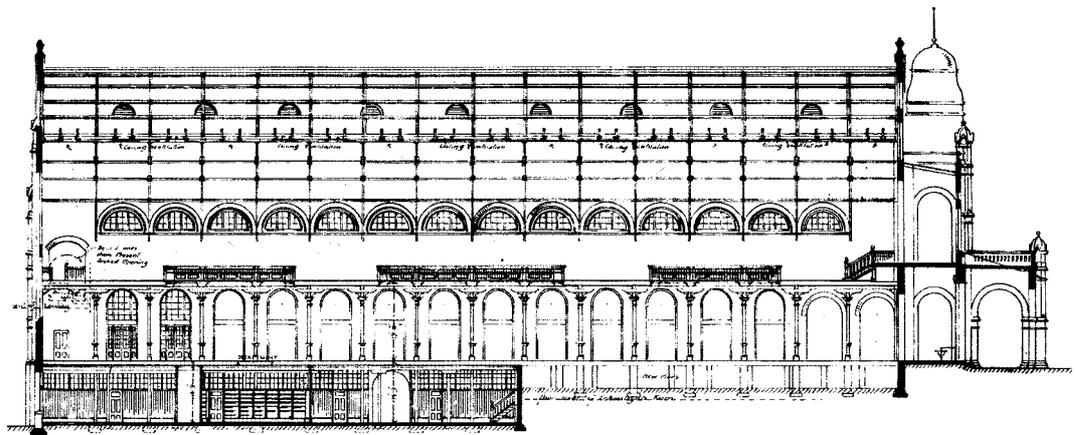
21
A contract drawing for the museum conversion of 1897. This section shows the dormer roof vents, ceiling lining, clerestory windows and the mezzanine floor supported on timber posts, all of which were introduced in the former exhibition hall. In the basement, the former dining room is converted to offices and preparation rooms for the museum staff, using some timber removed from dividing partitions in the exhibition hall.

Tenders were called in March 1899 for the *Alteration To Exhibition Building For Museum*.⁷¹ The design provided for construction of a gallery within the main hall, and addition of a line of windows in the main northern wall to light the new gallery. The basement dining room was modified to become offices, preparation and storage spaces.

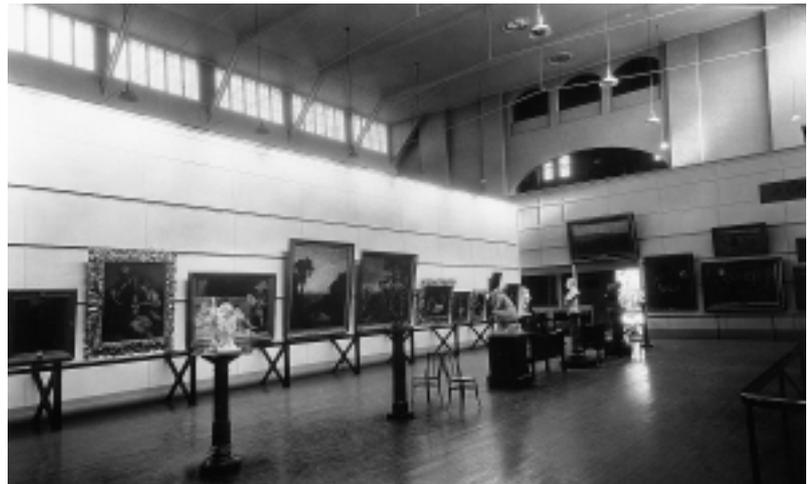
24
The interior of the Queensland Art Gallery soon after the conversion. [Department of Public Works photo 1931].

The change of function from concert hall to art gallery required substantial changes to be made to the concert hall. The organ had already been removed to the new City Hall; the choir platform was demolished and the raked floor raised and set level with the stage.⁸⁸ The timber filling the two arched bays at the end of the hall was removed. The upper galleries were modified – part of the gallery floor framing was removed, along with the tiered floor, and a new floor was installed at a higher level. New timber framed walls defined a line of intimate spaces around the edges of the auditorium on two levels. New partitions for hanging art works divided the ground floor. Cross partitions were placed on the gallery to create intimate spaces for hanging smaller pictures. Providing sufficient lighting to the gallery was seen as a major problem and this was overcome ...by the erection of continuous dormer lights, set immediately below the ceiling line, on each side of the roof.⁸⁹

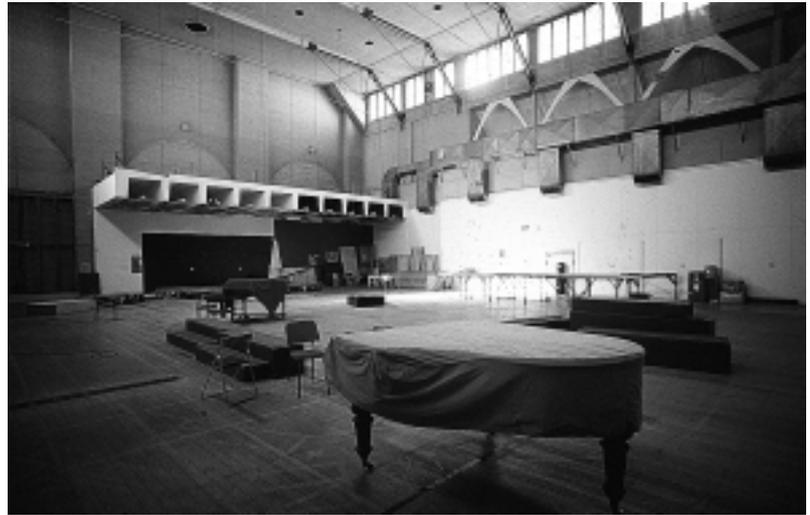
The concert hall in 1989. Note the evidence of a succession of uses: The dormer windows and flat floor date from the 1930 art gallery conversion, and the air ducts remain from a later refurbishment of the gallery, when a suspended ceiling was installed (since removed). Queensland Museum staff took over the space after 1974 and used it for storage and display preparation – you can see a prototype of the ceiling system for the new museum building at South Brisbane, used for testing and developing lighting and display systems in preparation for the move. When the picture was taken the Queensland Youth Orchestra was already using the space for rehearsals.

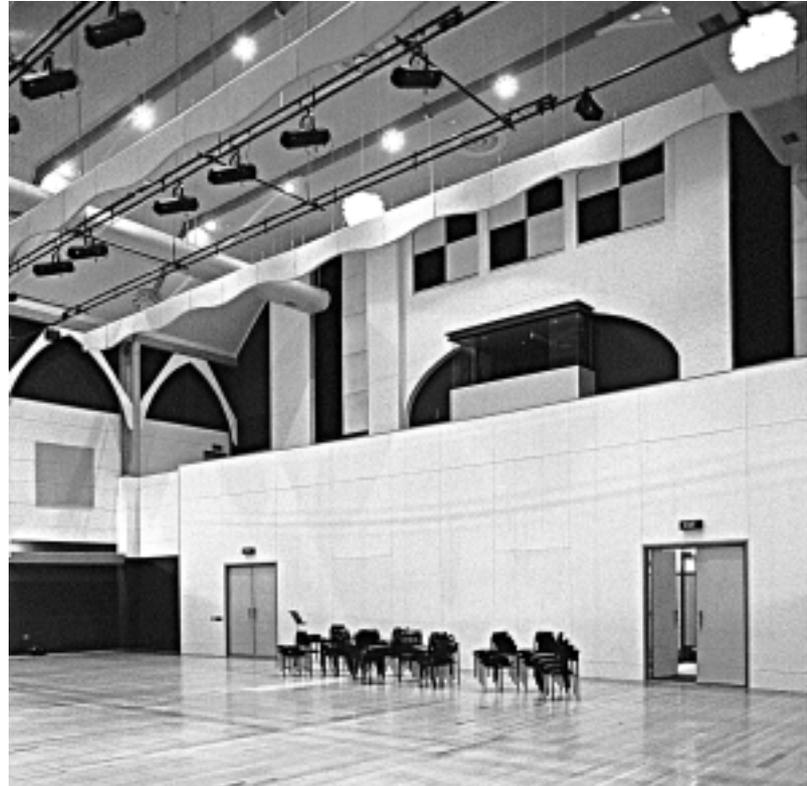
The concert hall in 1999 after conversion for use as a concert venue. The main changes visible in this picture are the new wall separating the auditorium from the foyer spaces, the new lighting and sound control room, the reconstruction of the ceiling to blank off the dormer windows, air conditioning ducts, acoustic baffles, suspended auditorium and stage lights.

- The raked part of the timber boarded ceiling was reconstructed in the original form, covering the 1930 dormer windows (the windows were left in place in the roof).
- New side walls (east and west) were built to form a *box within a box*⁹¹ to isolate the concert hall from outside noises. These walls replace walls introduced during the 1930 art gallery conversion, but are in a slightly different position, so that they stand clear of the original posts and braces.
- At the southern end of the hall, a new wall was built as part of the *box within a box*, supporting a high level flat floored gallery used for follow spots, lighting control and the like.
- An enclosed lighting and sound control box was built in the original southern upper gallery.
- A new stage was constructed.

- The concert hall was air-conditioned
- Acoustic devices, including absorbent panels on the side walls and hung across the auditorium, were installed.
- Sound reflective panels were installed over the stage, supported by a steel framework cantilevered from posts installed in the exhibition hall.

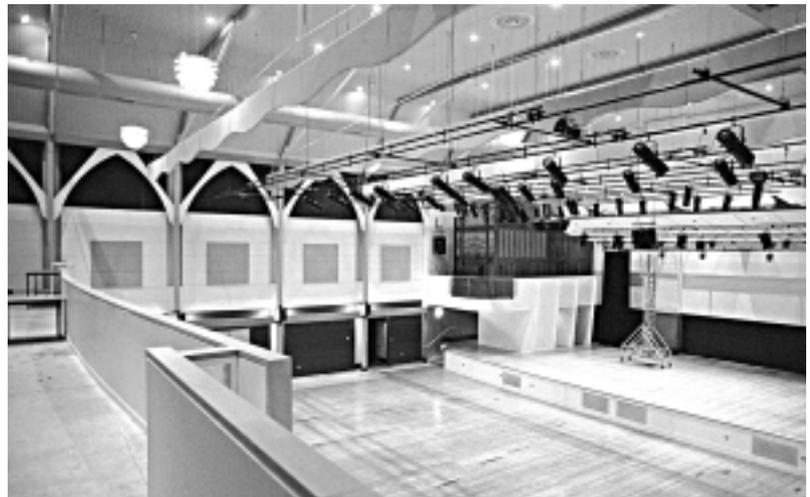
27
The concert hall in 1999 showing the St Stephen's Cathedral organ installed on a platform on stage right. This picture also shows the sound shell over the stage, the stage itself, and the balcony where the camera was.

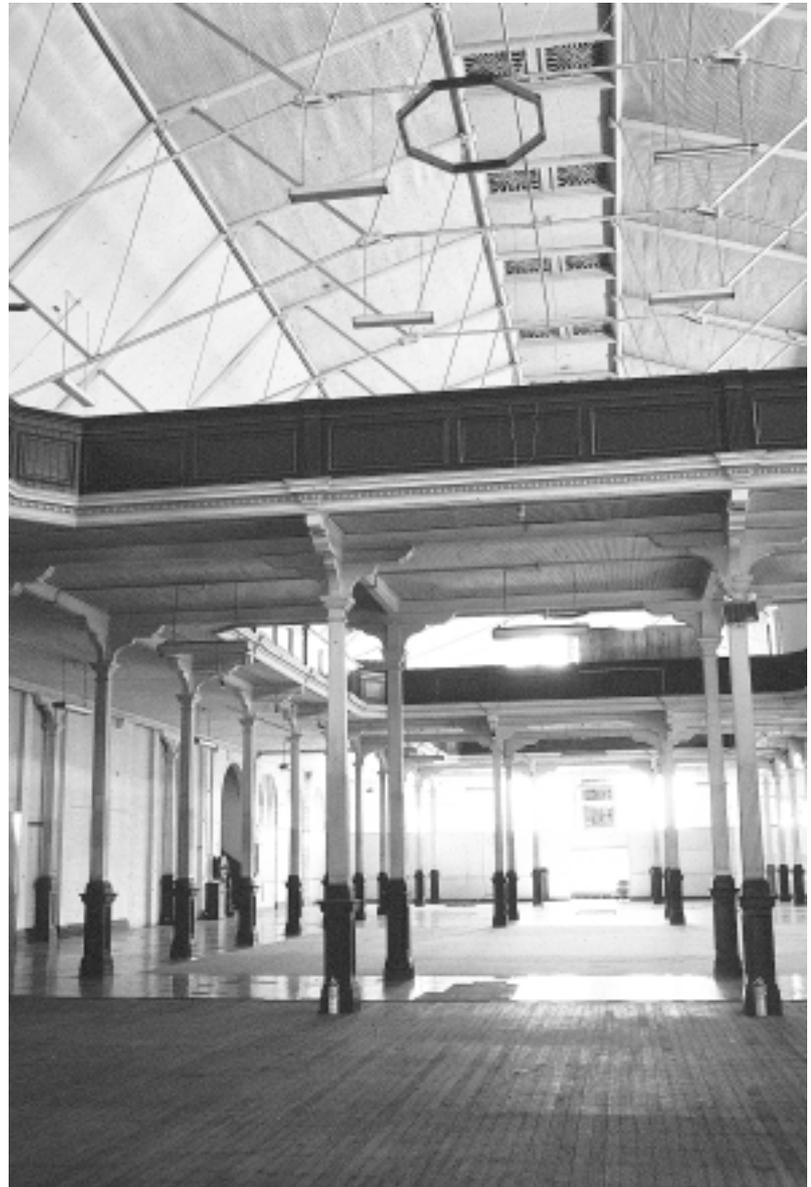
The exhibition hall in 1989, standing empty after the Queensland Museum moved to South Brisbane. The 1899 mezzanine, with its three large voids, was a light and sympathetic intrusion in the space of Addison's great open hall. The main elements of the 1899 conversion are the mezzanine, the metal ceiling and the high level windows that suffuse the mezzanine with light.

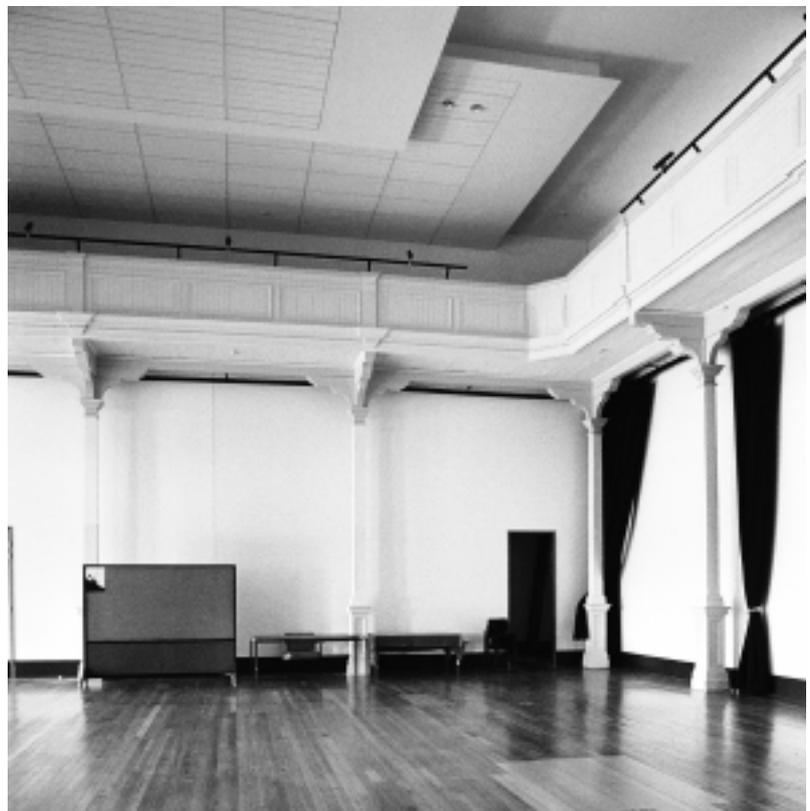
29
The central part of the exhibition hall after recent conversion work. The space beneath the central void in the mezzanine has been enclosed with walls below the mezzanine and with a ceiling above.
